# DCF77

V2.00 Siemens Edition

Time Synchronisation Service  
for

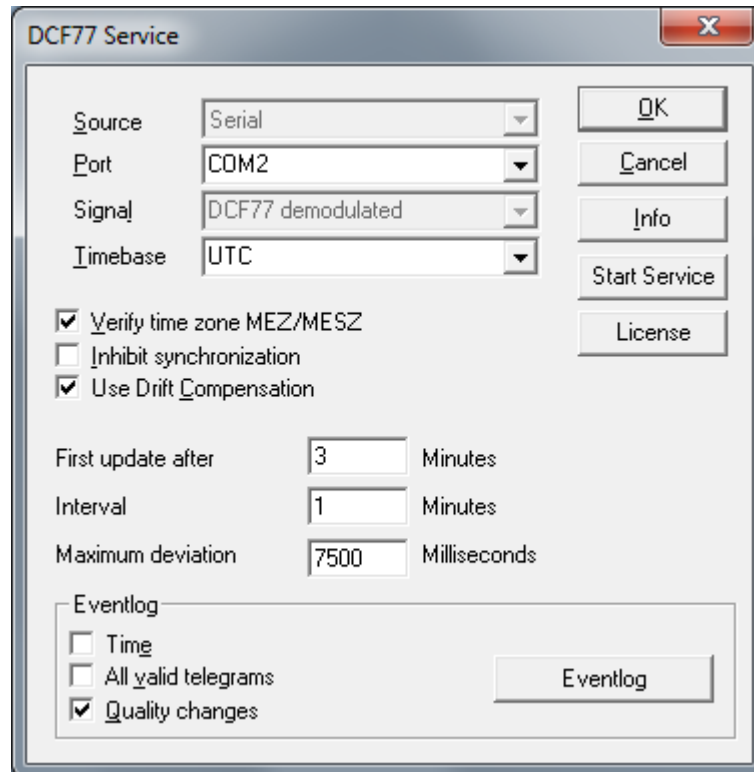
The time synchronization service installs an application called “DCF77 Settings” under “All Programs”, which allows you to change the settings. For that purpose, start this application.

A description of the different parameters can be found in chapter *Registry Database* (page 9).

Parameter changes will only become effective after restarting the service, as the DCF77 Service reads the current settings from the registry database only during startup.
